USE OF GEOMEMBRANES IN BUREAU OF RECLAMATION CANALS, RESERVOIRS, AND DAM REHABILITATION

**December 1995
Technical Service Center**

**U.S. Department of the Interior
Bureau of Reclamation**

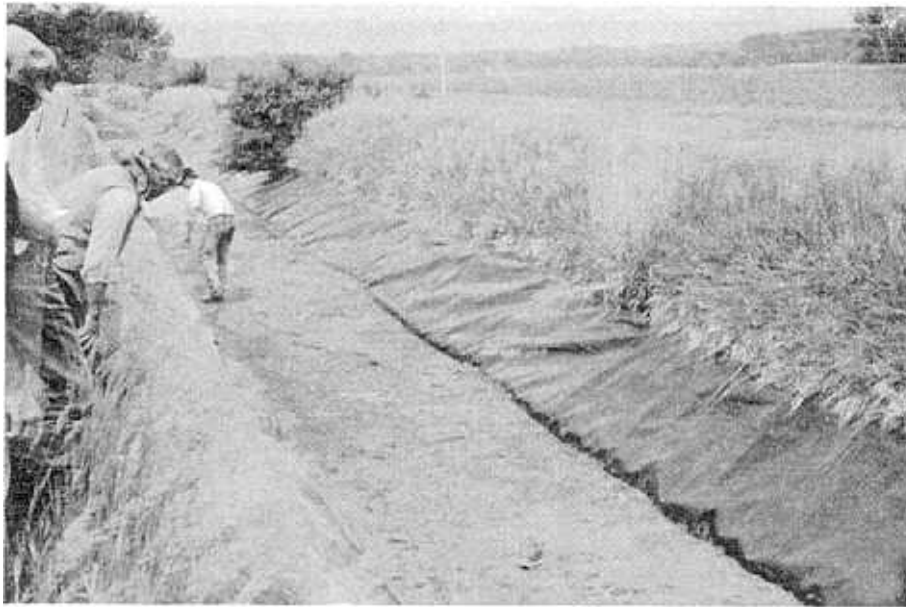
Field inspections were made in 1985 (Frobel, 1983) and 1991 (Bureau of Reclamation, 1986b) after 8 years of service. Photographs taken during the latter inspection are shown on figures 121 to 123. Several folds and creases were examined, and no membrane deterioration was noted. The membrane appeared to be in good condition.

Figure 121. - View of test section of HDPE geomembrane in White Rock Extension Canal after 8 years of service. Photograph was taken May 29, 1991.

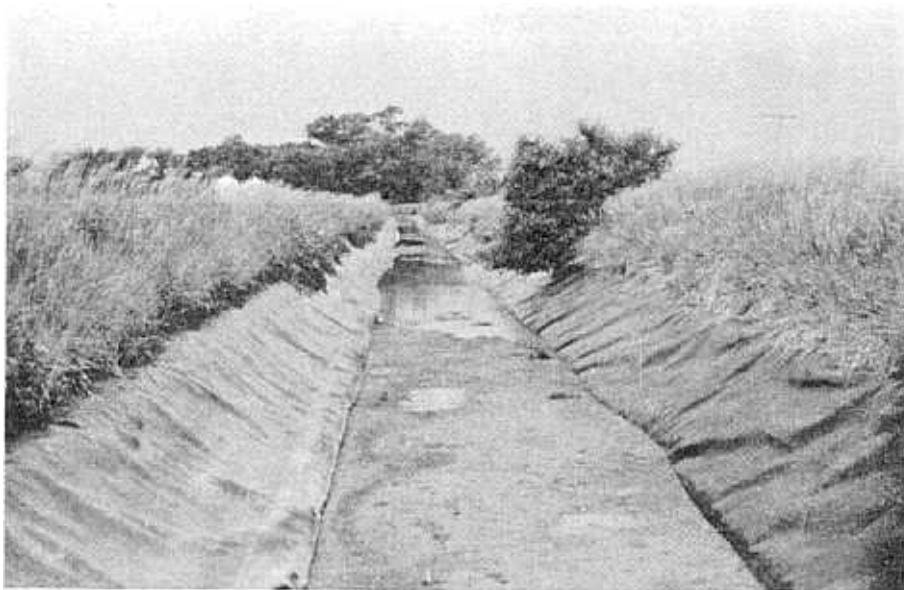
Figure 122. - Another view of test section shown on figure 121

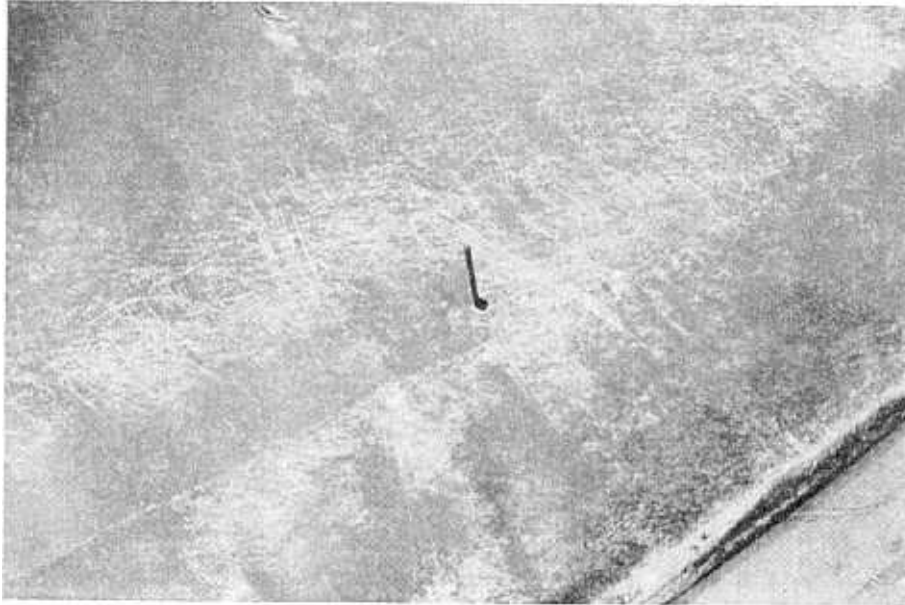
The field reported (Reclamation, 1992a) that the exposed geomembrane is performing satisfactorily after 8 years. Small holes believed to have been caused by deer were noted (figs. 124 and 125). Membrane tautness and undulations in the subgrade surface appear to indicate that the membrane has "bridged" across depressions or voids in the subgrade. Each hole appeared to have a void behind the membrane. The depression or void may have been caused either by the initial subgrade surface or by subsequent settlement caused by saturation from water leaking through the holes.

Figure 123. - Small hole in left side of test section of HDPE geomembrane. Photograph was taken May 29, 1991

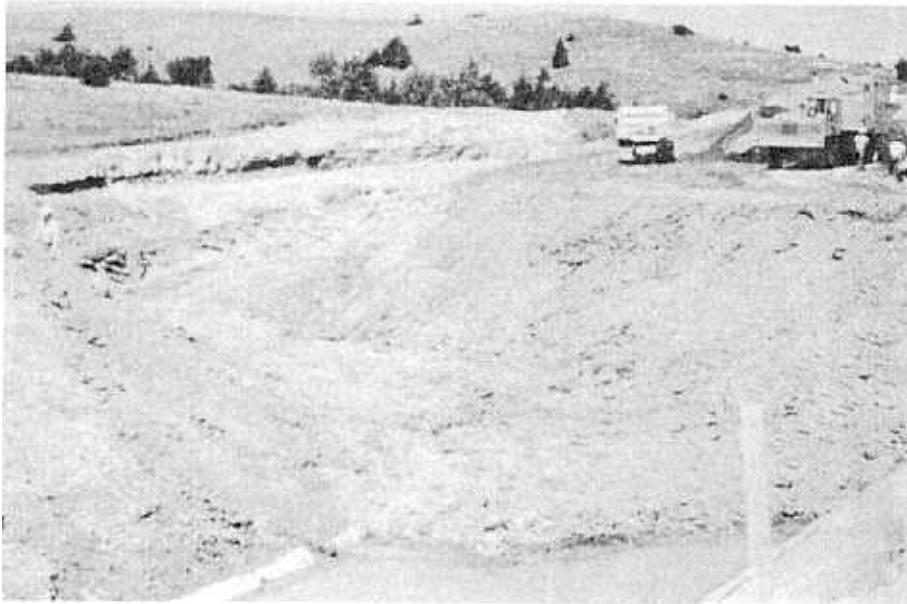
Figure 128. - To put the Mirdan Canal back into operation, a temporary bypass channel was built around the damaged lining.

To put the canal back into operation, a temporary bypass channel was built around the damaged lining (fig. 128) and was lined with PVC (fig. 129). For permanent repair, specifications (Bureau of Reclamation, 1987b) were prepared and issued to cover the following items:

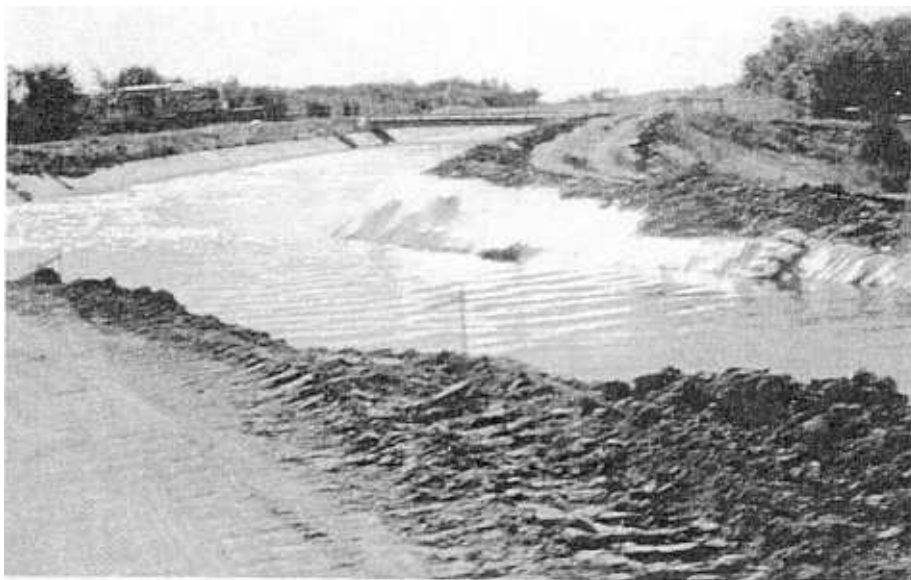
Figure 129. - View of temporary bypass channel for Mirdan Canal lined with 0.5-mm (20-mil) PVC geomembrane.

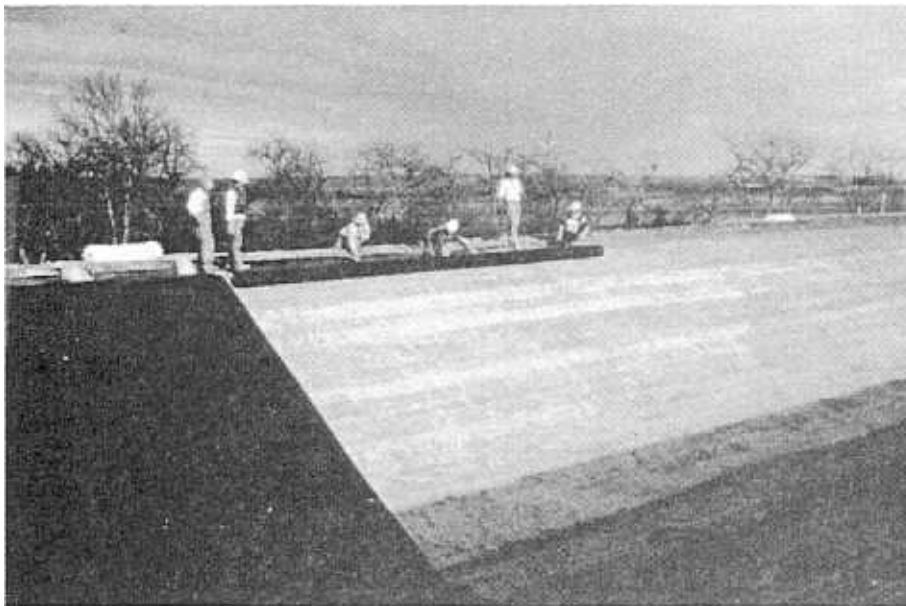
Figure 131. - Installation of 1.0-mm (40-mil) HDPE geomembrane in Mirdan Canal. Material was furnished in rolls about 10 m (33 ft) wide.

- a. Removal of damaged concrete
- b. Subgrade preparation, which entailed maintaining the original 1.5:1 side slopes (fig. 130)
- c. Installation of a 1.0-mm (40-mil) HDPE liner
- d. Installation of a fabric form concrete protective revetment on the side slopes and a gravel cover in the canal invert.

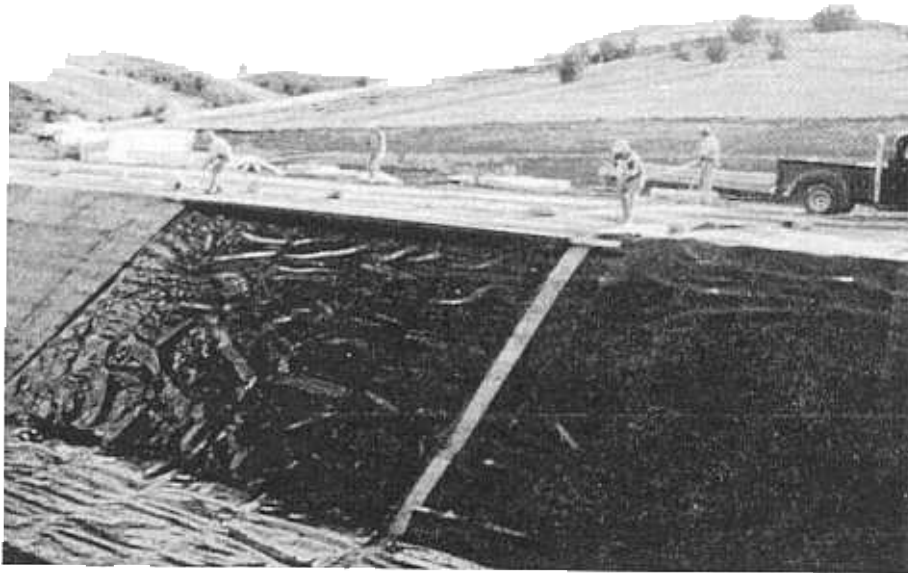
Figure 132. - Positioning HDPE geomembrane prior to heat welding the adjacent sheets.

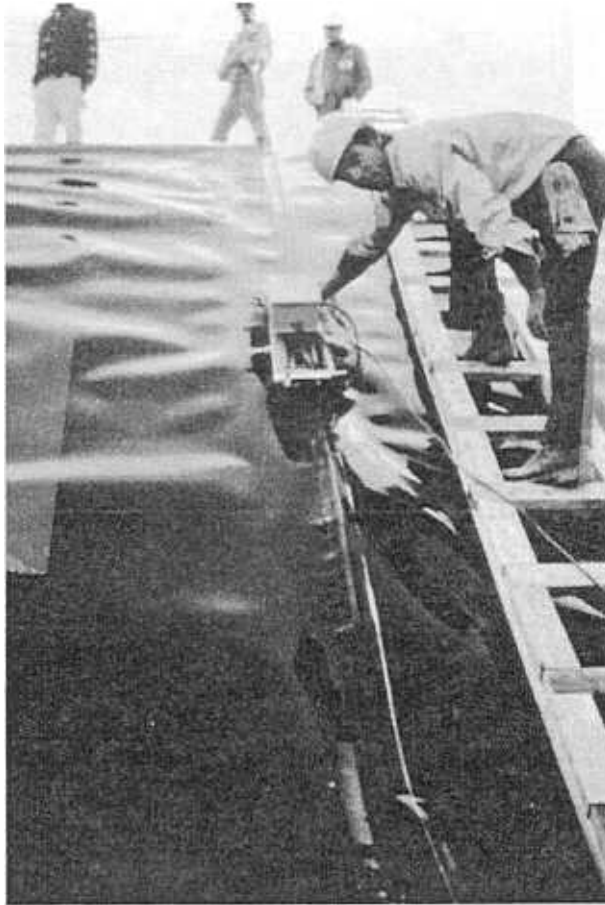
Figure 133. - Heat-welding HDPE geomembrane in Mirdan Canal.

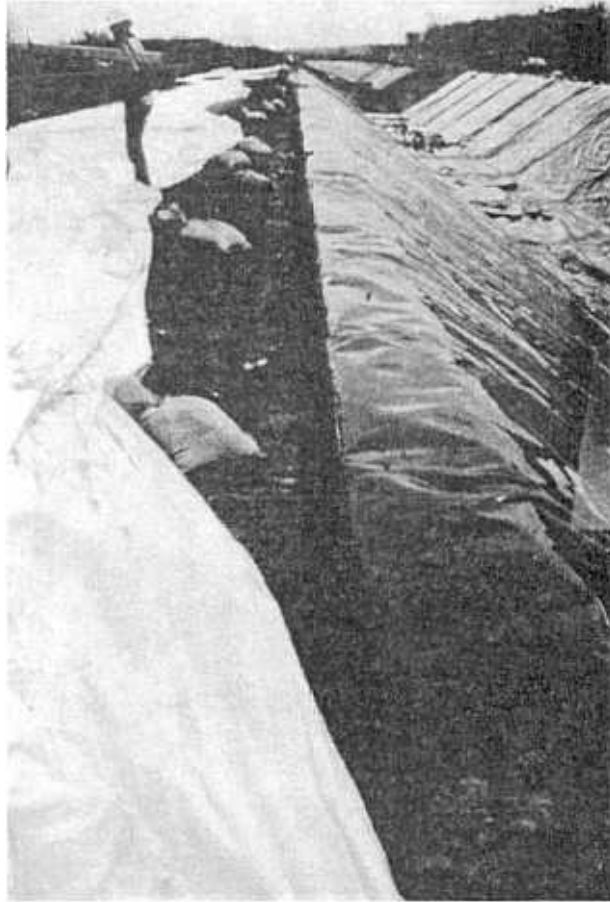
Figure 134. - Installation of fabric form concrete protective revetment material. Note anchor trench for HDPE and fabric materials. After installation of the fabric, as shown on figure 135, a concrete grout mix will be pumped into the fabric to form a hard-surface lining to protect the HDPE geomembrane.

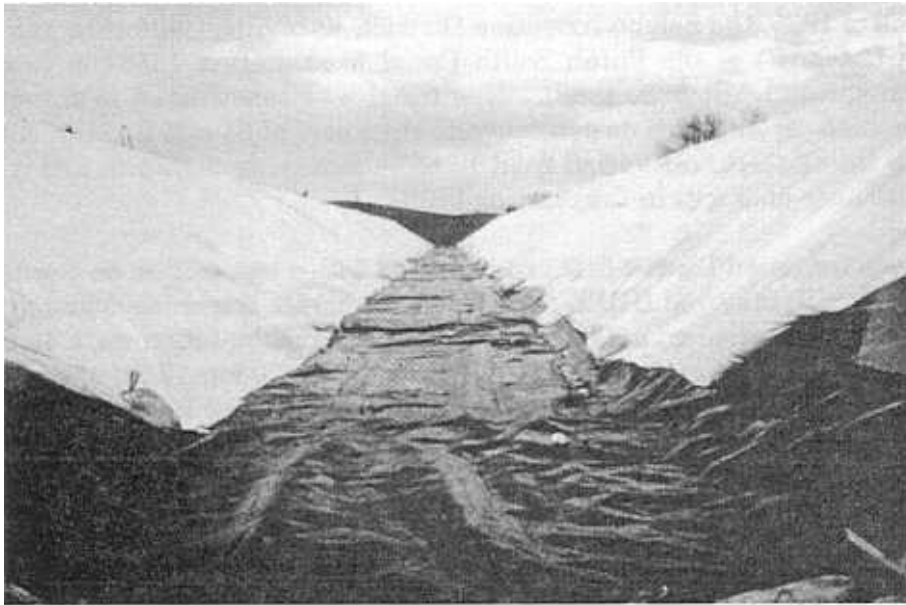
Figure 135. - View of fabric form concrete protective revetment material on side slopes prior to injection of concrete grout.

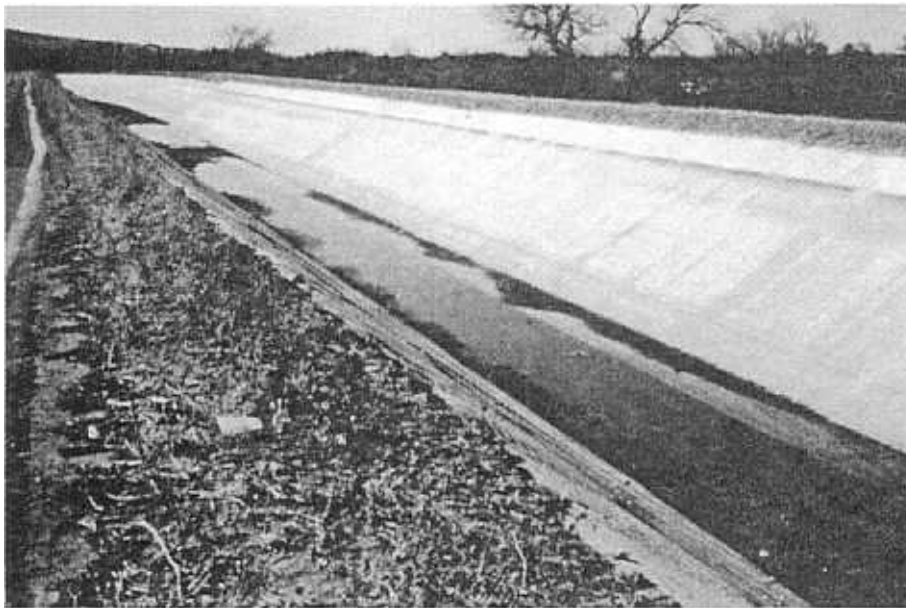
Field personnel reported in February 1992 that the performance of the repair has been satisfactory, and no maintenance or operational problems have occurred with the membrane. Because the bottom is usually covered with water, visual inspection of the gravel cover material has not been made.

Concrete shrinkage cracks in the concrete revetment on the sides have taken place, but the concrete serves only to protect the membrane liner and does not function as a seepage barrier. Water migrating through the concrete can escape through the weep/drain valves that are in place in the fabric formed concrete.

Figure 136. - View of completed repair section in Mirdan Canal.

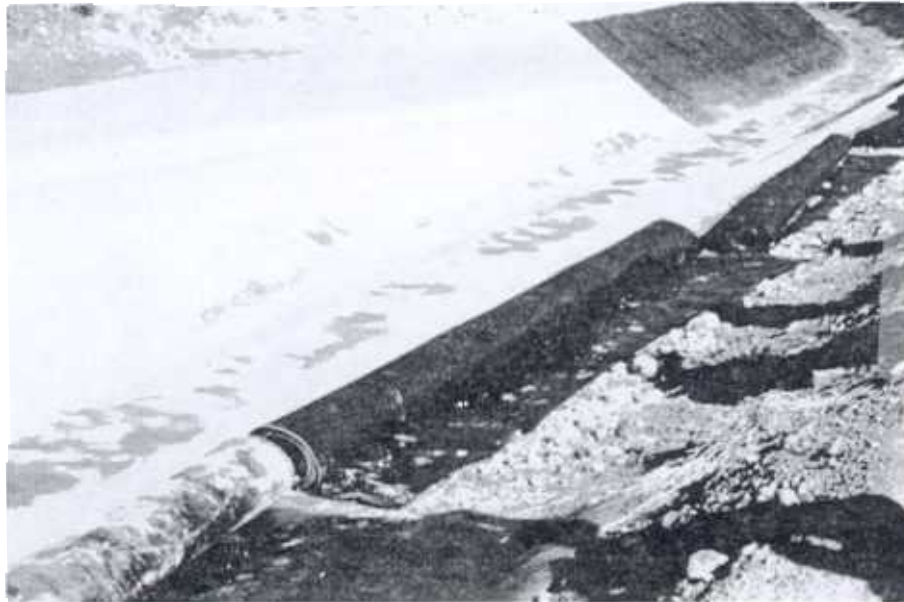
In the fall of 1989, the Solano Irrigation District, Vacaville, California, rehabilitated about 1500 m (5,000 ft) of the Putah South Canal from station 1559+00 to station 1610+16 (Straubinger and Mitchell, 1989). This canal was constructed in the early 1950s as a concrete-lined canal with a design concrete thickness of 64 mm (2.5 in). Tests have shown that the lining thickness varied from 13 to 64 mm ($\frac{1}{2}$ to 2-1/2 in), and it has continually leaked because of cracks in the existing lining.

Figure 137. - Use of shotcrete/geomembrane system to repair concrete lining in Putah South Canal, Solano Irrigation District, California. View shows installation of 1.0-mm (40-mil) texturized HDPE lining.

The Solano Irrigation District first experimented with a test section on Byrnes Lateral using 1.5-mm (60-mil) textured HDPE and various shotcrete thicknesses and differing amounts of fibermesh reinforcement in the mix. For the main rehabilitation work on the Putah South Canal, they used 1.0-mm (40-mil) textured HDPE with 50 mm (2 in) of shotcrete lining that had 1.2 kg/m³ (2 lb/yd³) of fibermesh reinforcement in the mix to reduce cracking. The geomembrane was nailed into the existing concrete along the top of the berm and the transverse seams were hot wedge welded. The shotcrete was then applied over the geomembrane. Open transverse joints at about 3.7-m (12-ft) centers were tooled into the shotcrete. The rehabilitation work is shown on figures 137 to 141.

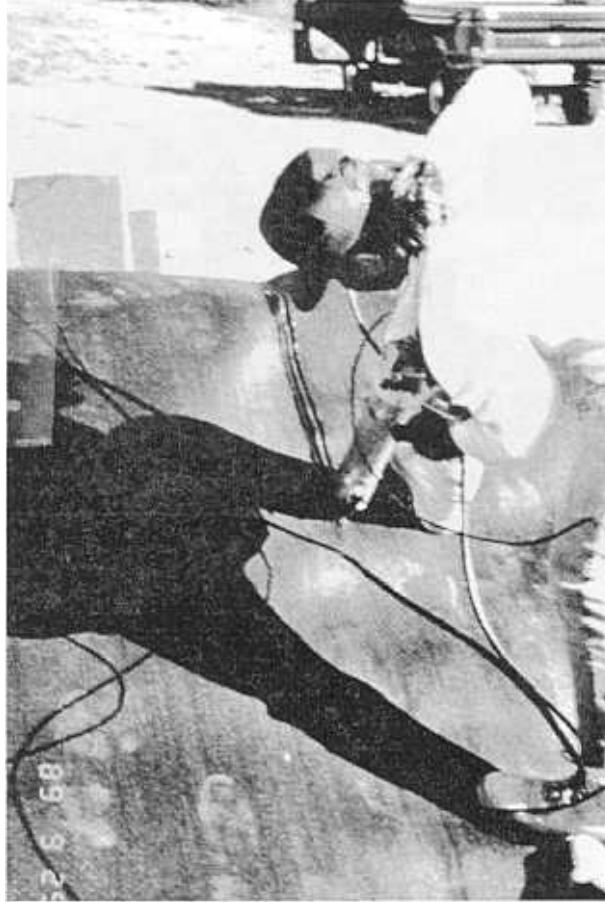
Figure 138. - Field seaming of texturized HDPE lining using hot welding methods.

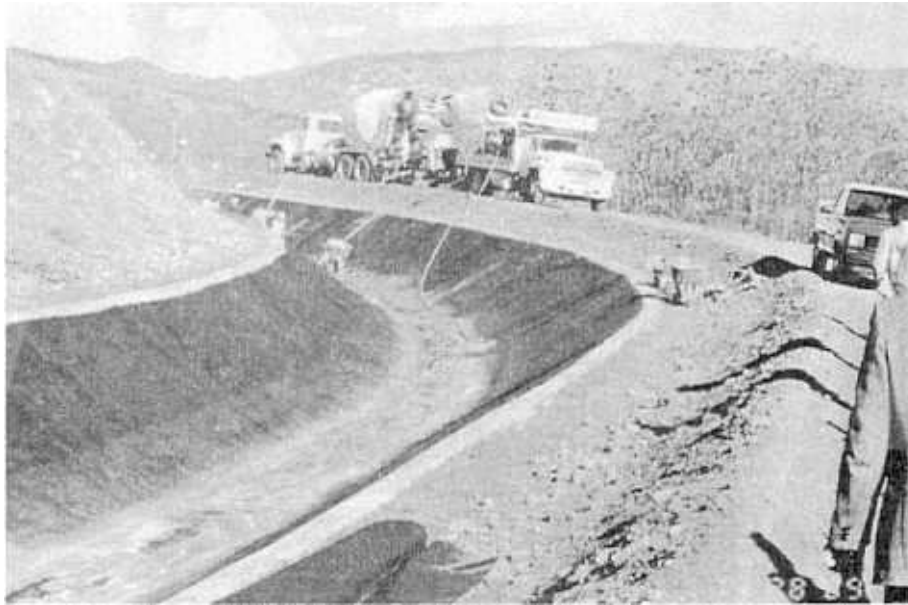
Figure 139. - View of installed texturized HDPE geomembrane in Putah South Canal. About 1500 m (5,000 ft) of concrete lining were repaired.

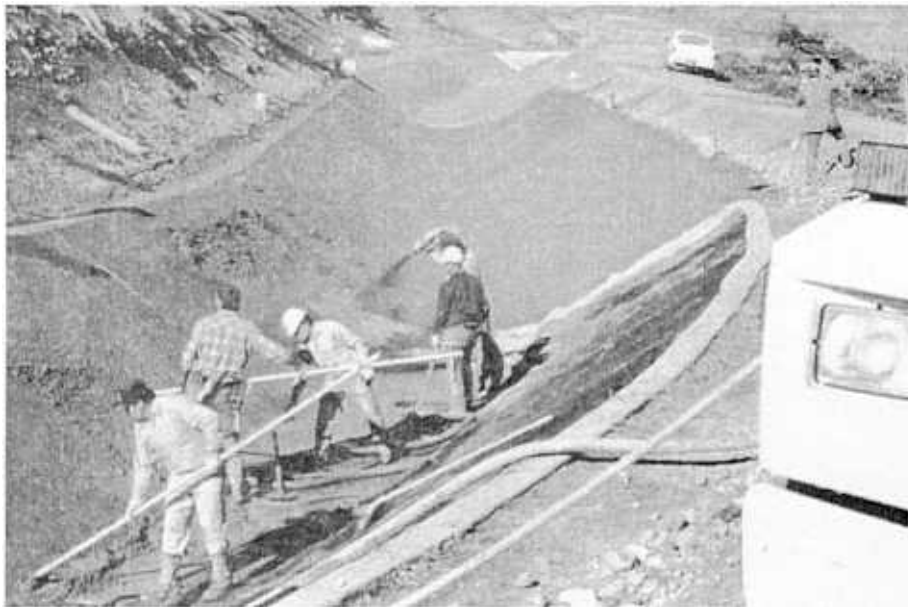
Figure 140. - Applying shotcrete to texturized HDPE lining in Putah South Canal. Thickness of the shotcrete was about 51 mm (2 in).

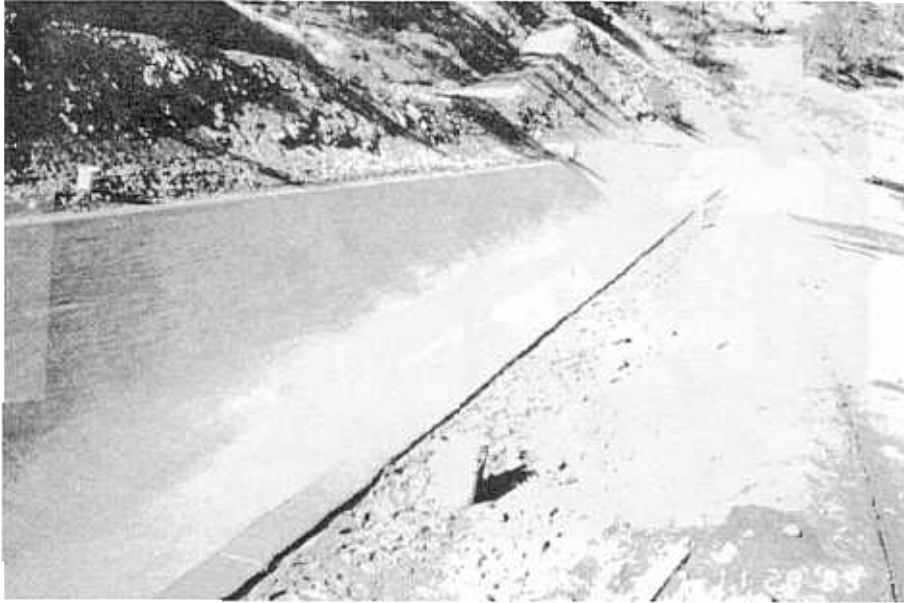
Figure 141. - Completed repair section on Putah South Canal. Repair work was accomplished the fall of 1989.

In January 1992, after 26 months of service, Solano Irrigation District personnel reported (Straubinger, 1992) that they were pleased with the results of the rehabilitation work. The previous soil saturation/water leakage problems down slope from the canal are no longer a problem. Before the repair work, the water level in the canal was purposely kept low; after repairs, the water level could be raised to its design level. They also reported that the canal has been drained and cleaned at least twice since the repair work without incurring damage to the shotcrete lining. The performance of this repair will continue to be monitored.

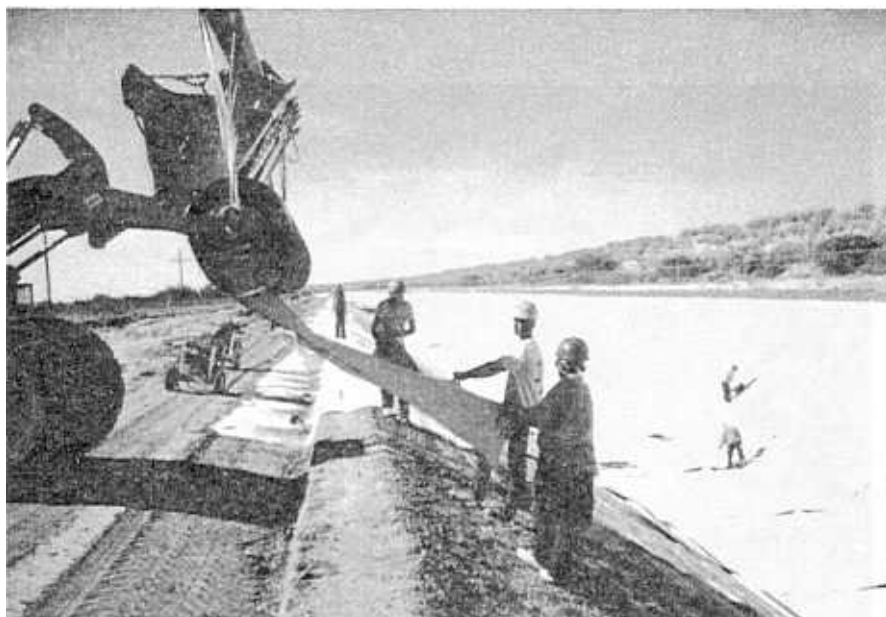
About 2.4 kilometers (1.5 mi) of the Tucson Aqueduct Reach 3 concrete lining was found to be cracked, broken and buckled because of settlement of saturated foundation materials. To minimize repair time and cost, a geomembrane was selected rather than overexcavation and replacement of the subgrade and concrete canal lining.

Figure 42 Unrolling geomembrane for pipeline at the Tucson Aqueduct Reach repair

Repairs took place in November 1994. Figure 142 shows geomembrane placement following subgrade preparation. Specifications required removal of concrete chunks or smoothing of existing surfaces to provide no offsets greater than 20 mm (3/4 in). Following geomembrane placement, a 75-mm (3-in) layer of shotcrete was applied to the geomembrane surface as shown on figures 143 and 144. This repair will be monitored to determine its effectiveness.

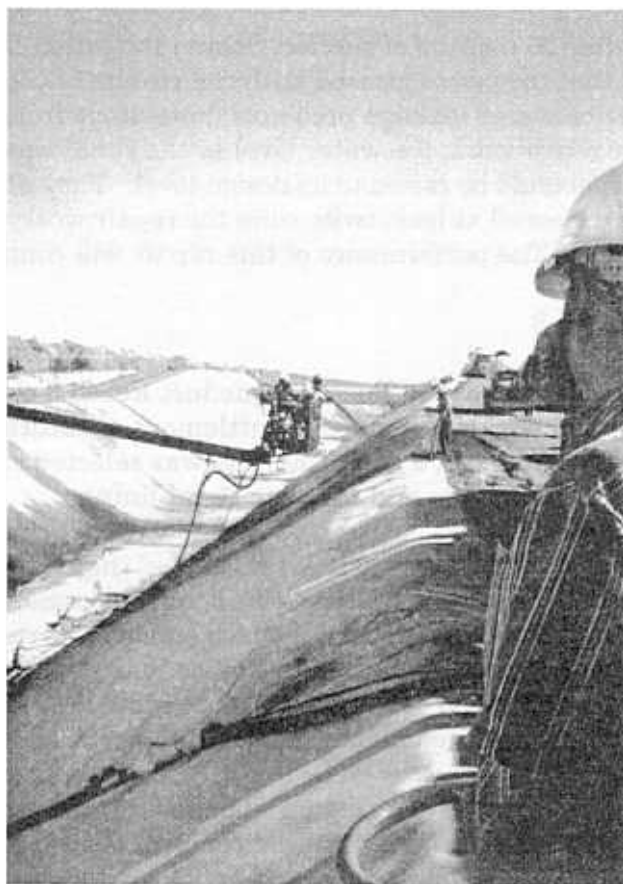
Figure Shotcreting the VLDPE textured geomembrane at the Aqueduct Reach

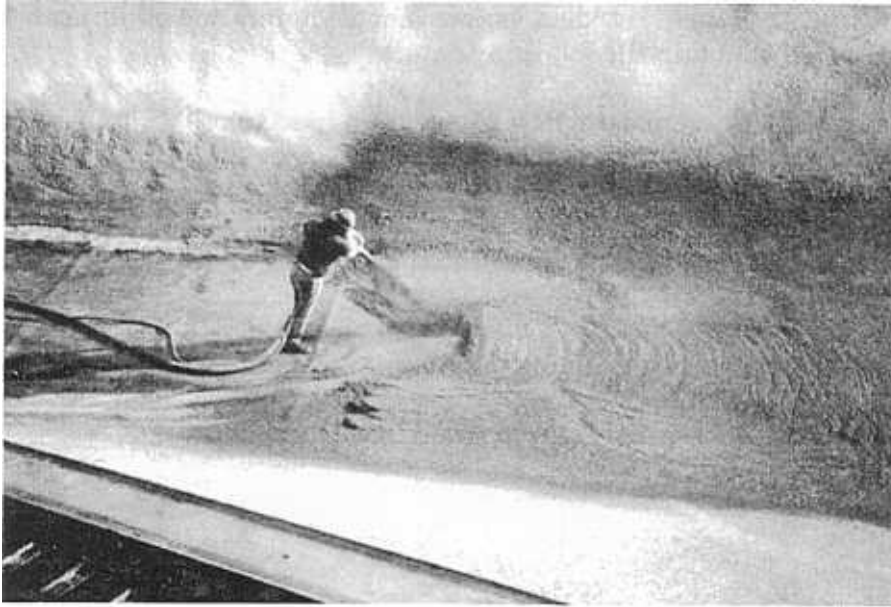
Figure 144. - Shotcreting over the geomembrane in the canal invert of the Tucson Aqueduct Reach 3.
